PRE REFURBISHMENT/DEMOLITION

45 Beverley Drive, Bentilee, Stoke on Trent, ST2 0JG

J501503

2 Jun 2011

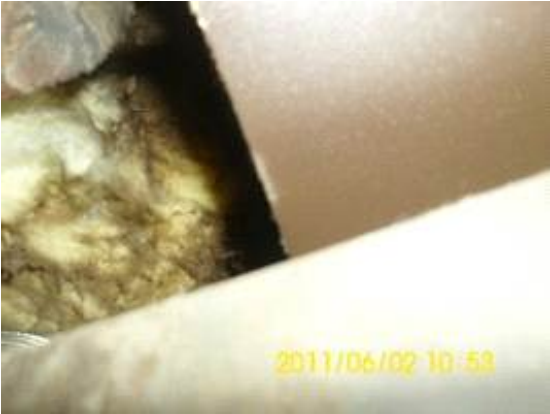
Sample	1 / AX000247	Product Type	-	Recommended Action No further action required.	
	Building	45 Beverley Drive	Damage / Deterioration	-		
	Location	Room 1 (Lounge)	Surface Treatment	-		
	Floor	Ground Floor	Accessibility	-		
	Product Description	mmmf insulation in chimney flue		Material Risk		-
	Fibre Identification	(0) No Asbestos Detected				
Room Information	laminated floor

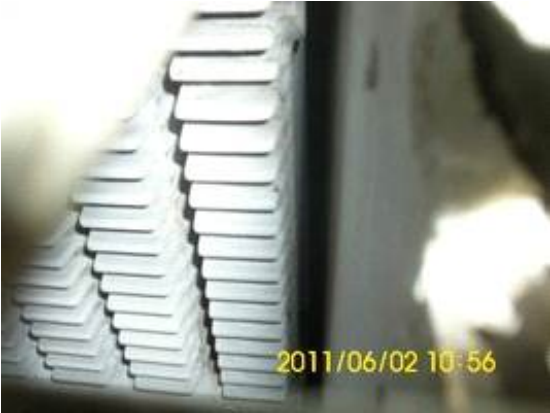
Sample	2 / AX000248	Product Type	-	Recommended Action No further action required.	
	Building	45 Beverley Drive	Damage / Deterioration	-		
	Location	Room 1 (Lounge)	Surface Treatment	-		
	Floor	Ground Floor	Accessibility	-		
	Product Description	Insulating board to back boiler		Material Risk		-
	Fibre Identification	(0) No Asbestos Detected				
Room Information	laminated floor

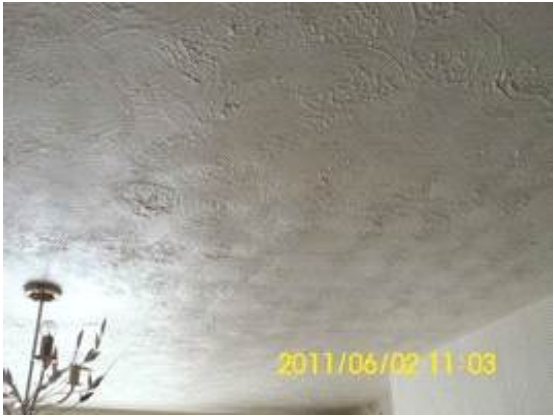
Sample	3 / AX000249	Product Type	-	Recommended Action No further action required.
	Building	45 Beverley Drive	Damage / Deterioration	-	
	Location	Room 1 (Lounge)	Surface Treatment	-	
	Floor	Ground Floor	Accessibility	-	
	Product Description	Textured coating to ceiling	Material Risk	-	
	Fibre Identification	(0) No Asbestos Detected			
Room Information	laminated floor

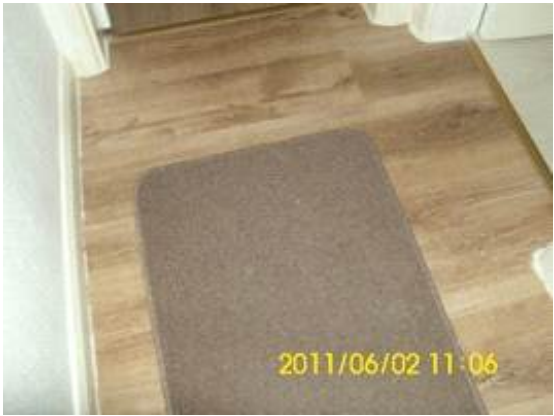
Sample	4	Product Type	-	Recommended Action Further Inspection Required
	Building	45 Beverley Drive	Damage / Deterioration	-	
	Location	Room 2 (Hall)	Surface Treatment	-	
	Floor	Ground Floor	Accessibility	-	
	Product Description	Vinyl floor tiles beneath laminate	Material Risk	-	
	Fibre Identification				
Room Information

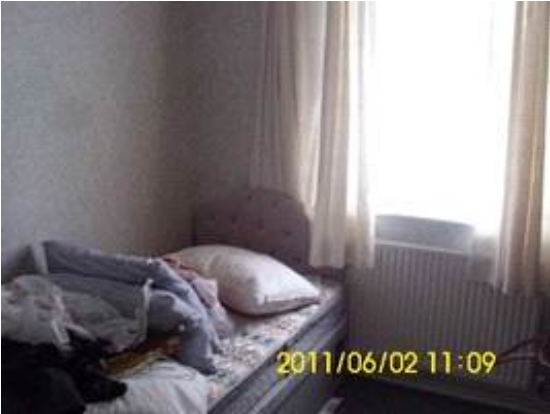
Sample	5	Product Type	-	Recommended Action No further action required.
	Building	45 Beverley Drive	Damage / Deterioration	-	
	Location	Room 3 (Bedroom 1)	Surface Treatment	-	
	Floor	Ground Floor	Accessibility	-	
	Product Description	accessed - no suspect materials found	Material Risk	-	
	Fibre Identification				
Room Information	carpet lifted no tiles

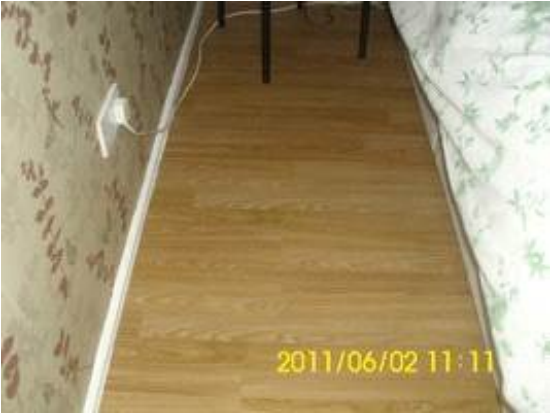
Sample	6	Product Type	-	Recommended Action Further Inspection Required
	Building	45 Beverley Drive	Damage / Deterioration	-	
	Location	Room 4 (Bedroom 2)	Surface Treatment	-	
	Floor	Ground Floor	Accessibility	-	
	Product Description	Vinyl floor tiles beneath laminate	Material Risk	-	
	Fibre Identification				
Room Information	Laminate floor

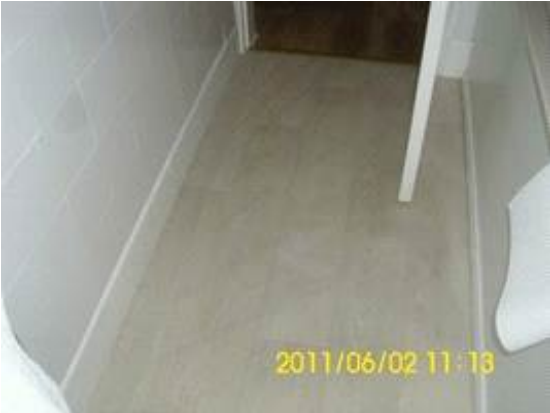
Sample	7	Product Type	-	Recommended Action Further Inspection Required
	Building	45 Beverley Drive	Damage / Deterioration	-	
	Location	Room 5 (Bathroom)	Surface Treatment	-	
	Floor	Ground Floor	Accessibility	-	
	Product Description	Vinyl floor tiles beneath sealed linoleum	Material Risk	-	
	Fibre Identification				
Room Information	Timber bath panel and boxing behind cistern, modern plaster coating to ceiling

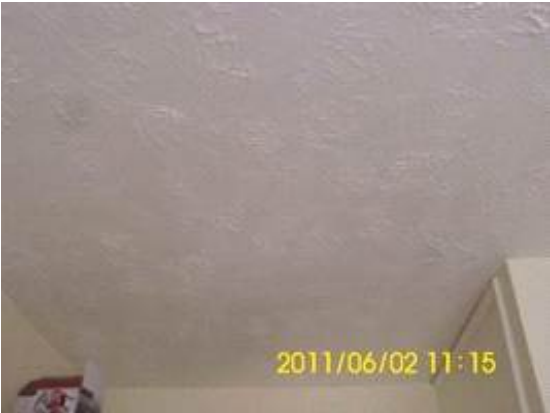
Sample	8 / AX000249	Product Type	-	Recommended Action No further action required.
	Building	45 Beverley Drive	Damage / Deterioration	-	
	Location	Room 6 (Kitchen)	Surface Treatment	-	
	Floor	Ground Floor	Accessibility	-	
	Product Description	Textured coating to ceiling (as sample AX000249)	Material Risk	-	
	Fibre Identification	(0) No Asbestos Detected			
Room Information	sealed linoleum flooring, non suspect electrics, plastic tank to top of cupboard

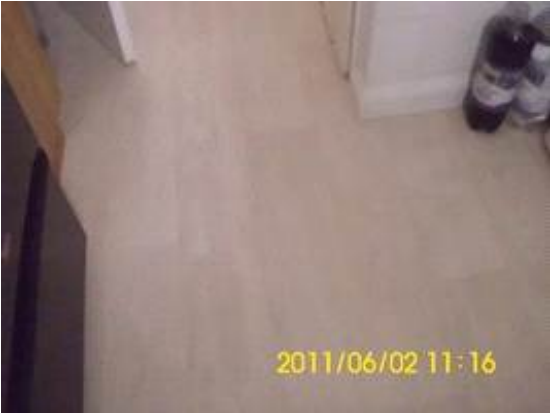
Sample	9	Product Type	-	Recommended Action Further Inspection Required
	Building	45 Beverley Drive	Damage / Deterioration	-	
	Location	Room 6 (Kitchen)	Surface Treatment	-	
	Floor	Ground Floor	Accessibility	-	
	Product Description	Vinyl floor tiles beneath sealed linoleum	Material Risk	-	
	Fibre Identification				
Room Information	sealed linoleum flooring, non suspect electrics, plastic tank to top of cupboard

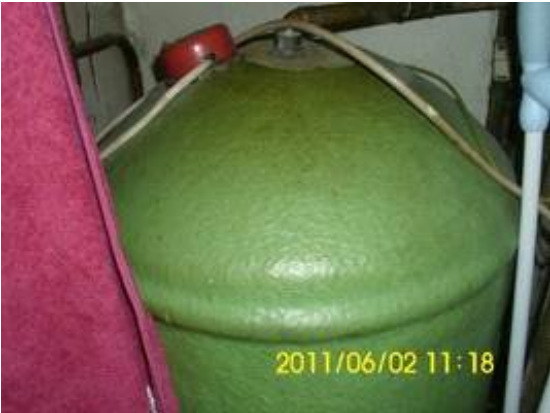
Sample	10	Product Type	-	Recommended Action Further Inspection Required
	Building	45 Beverley Drive	Damage / Deterioration	-	
	Location	Room 6 (Kitchen)	Surface Treatment	-	
	Floor	Ground Floor	Accessibility	-	
	Product Description	Gaskets to tank at bottom	Material Risk	-	
	Fibre Identification				
Room Information	sealed linoleum flooring, non suspect electrics, plastic tank to top of cupboard
